### **Evaluation of a Self-Contained Breathing Apparatus Involved in a Near Miss in the Fire Service**

Indianapolis, Indiana Fire Department Requested the Evaluation of a Scott® Safety Air-Pak® Plus 4.5, 4500 psi, 30 minute unit with NIOSH Approval Number TC-13F-76CBRN

## NIOSH Task Number 20931

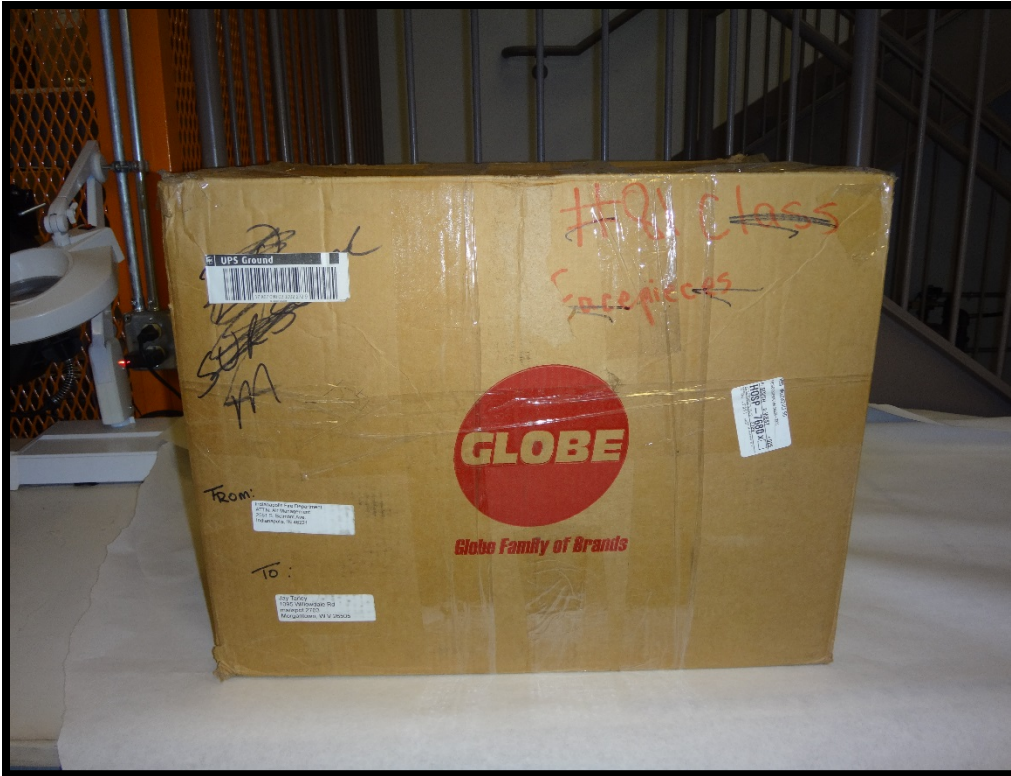
**Figure 1: SCBA as received in cardboard box**

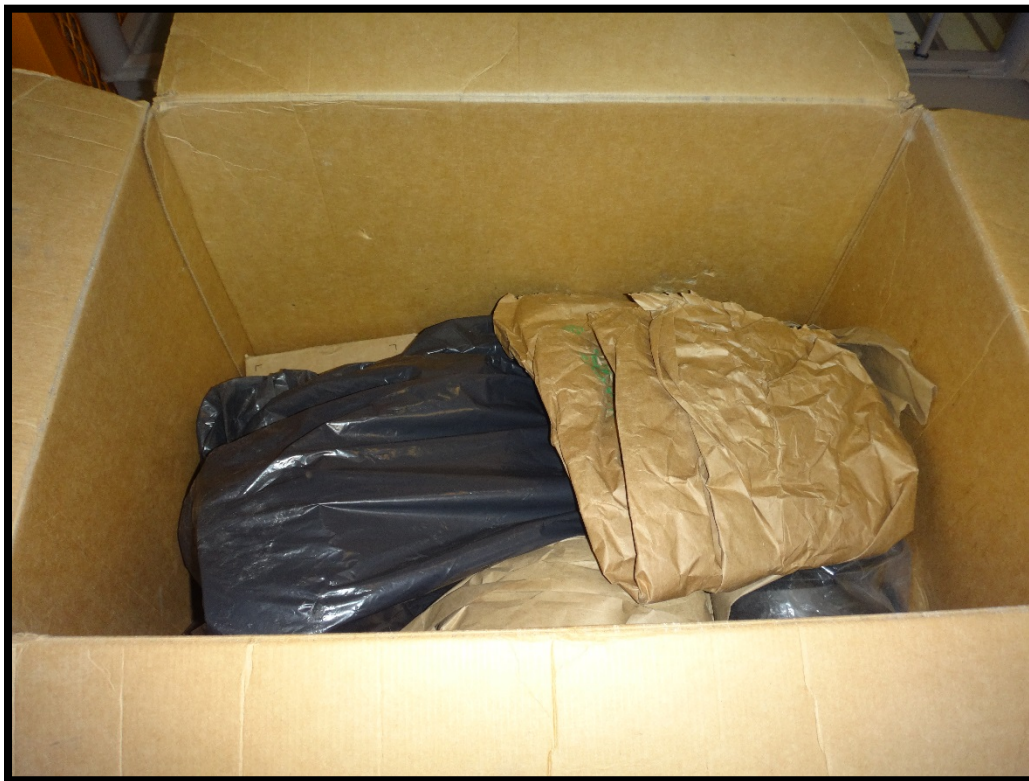
- Pack and cylinder in large plastic bag, facepiece in separate bag, mask mounted regulator (MMR) floating in box
- Cylinder received empty
- Bypass was ¾ closed
- Donning switch on, regulator inactive
- MMR disconnected from facepiece and unit
- Facepiece included

**Figure 2: SCBA unit in plastic bag inside box**

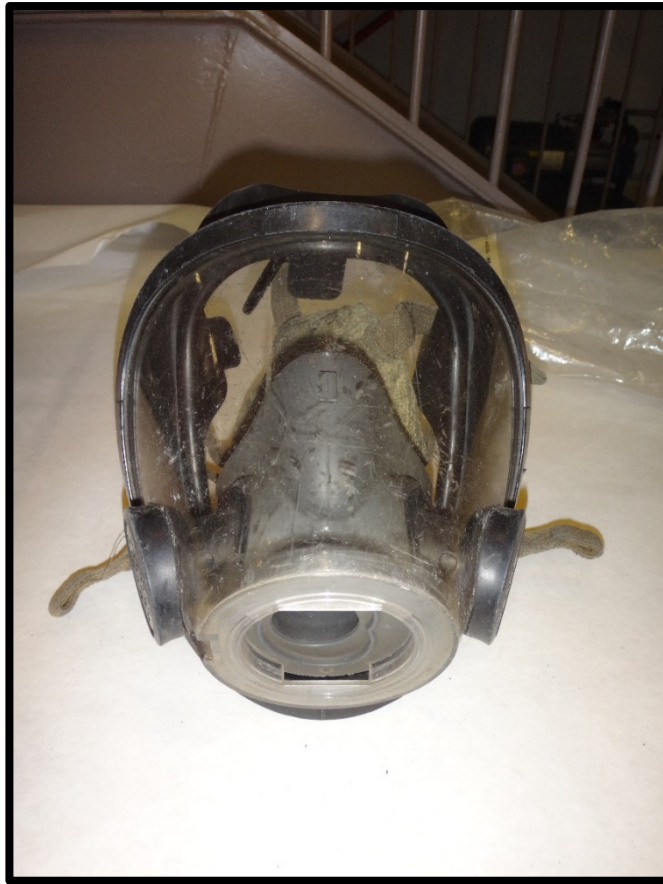
- Overall condition is good
- Lot number label is present

**Figure 5: Overview of facepiece**

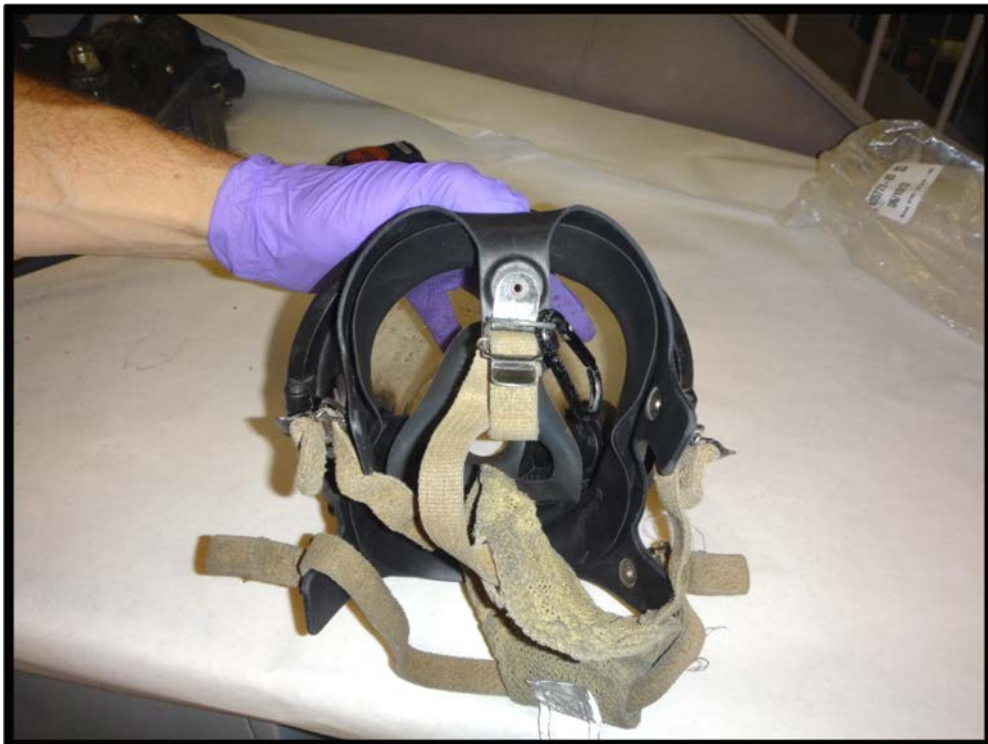
- Lens is good with some scratches
- Head harness is good, carabiner attached to top adjustment strap
- Head harness straps good, straps move freely, hold in place, held securely to facepiece, slightly dirty
- Attachment points for straps are good
- The facepiece seal “rubber” portion is excellent
- Regulator interface area is good, no debris

**Figure 6: Hairnet straps good/carabiner attached to top adjustment strap**

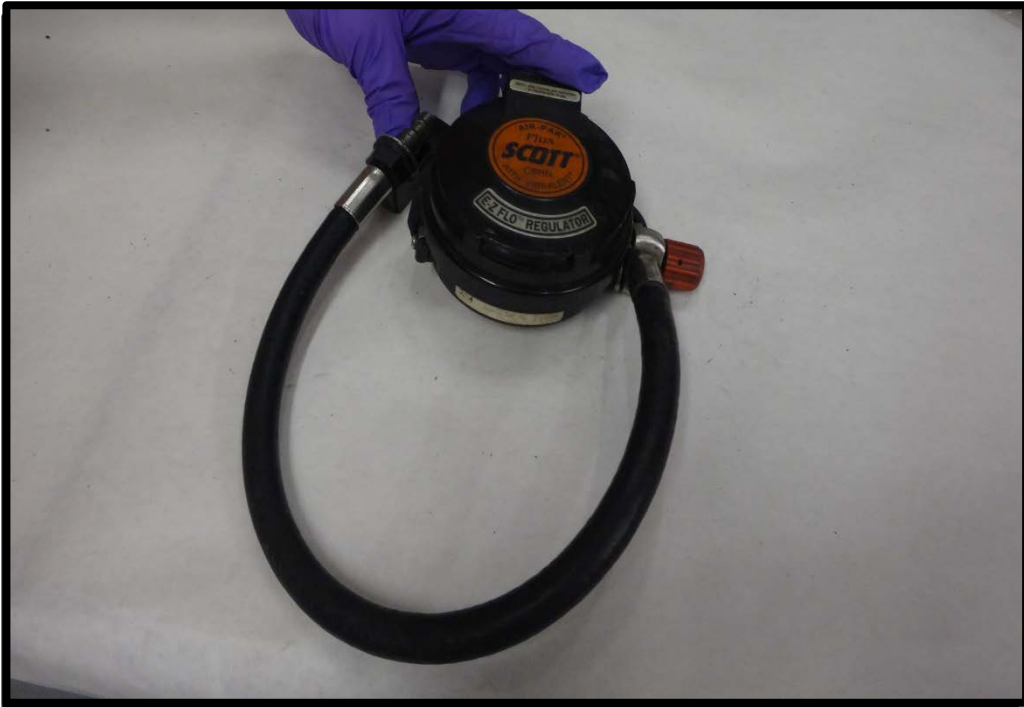
The unit also passed the NFPA “Airflow Performance” test. However, the original mask mounted regulator (MMR) could not pass the facepiece leakage test. The original facepiece was replaced with a NIOSH-owned Scott® Safety unit to ensure that the mask was indeed sealed and found the issue was with the fire original MMR. The original unit and MMR, as submitted by the Indianapolis Fire Department, were used for the NFPA breathing machine portion of the SCBA testing.

- Overall condition is good with no signs of heat damage
- Outer case is good and front label is in good condition
- Donning switch is in good condition. Switch is on, regulator inactive.
- Detached from pack at quick disconnect
- Bypass  $\frac{3}{4}$  closed
- Bypass knob fair shape
- Inside flange has minimal scratches, clean
- Sealing area mostly clean and in decent shape
- Regulator can be attached and removed
- Locking assembly does function

**Figure 11: Mask Mounted Regulator (MMR)**

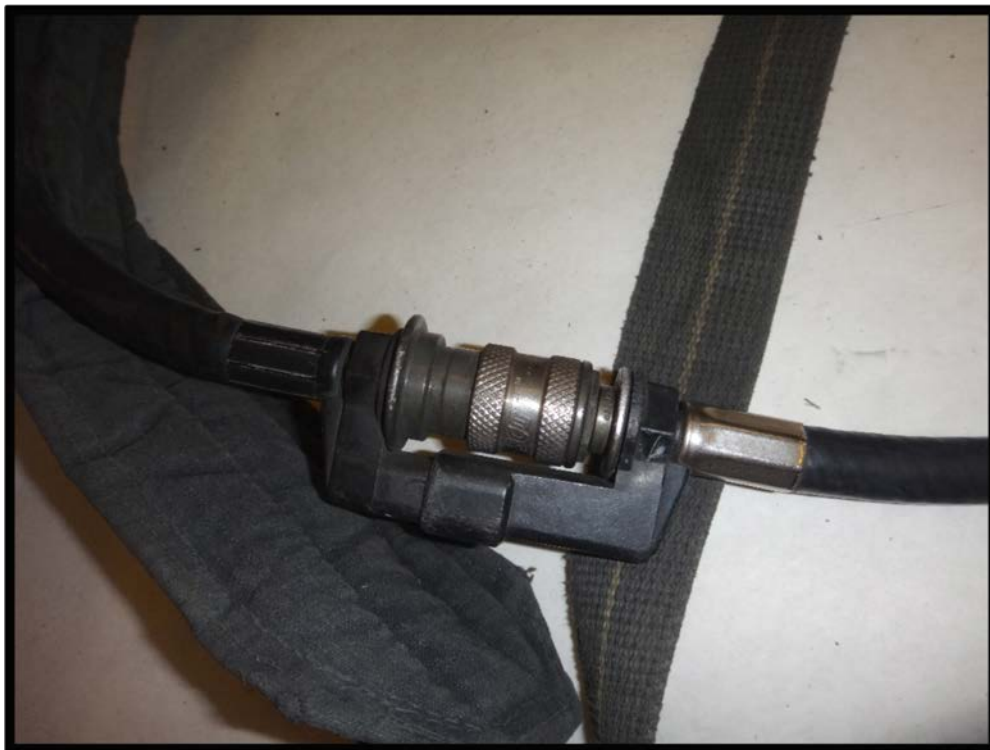
- Overall condition is good
- Detached from pack at quick disconnect
- Quick disconnect in good condition and functions
- Line runs through the shoulder strap to the reducer
- Signs of heat damage to shoulder straps

**Figure 16: Low pressure line and quick disconnect clean and functional**

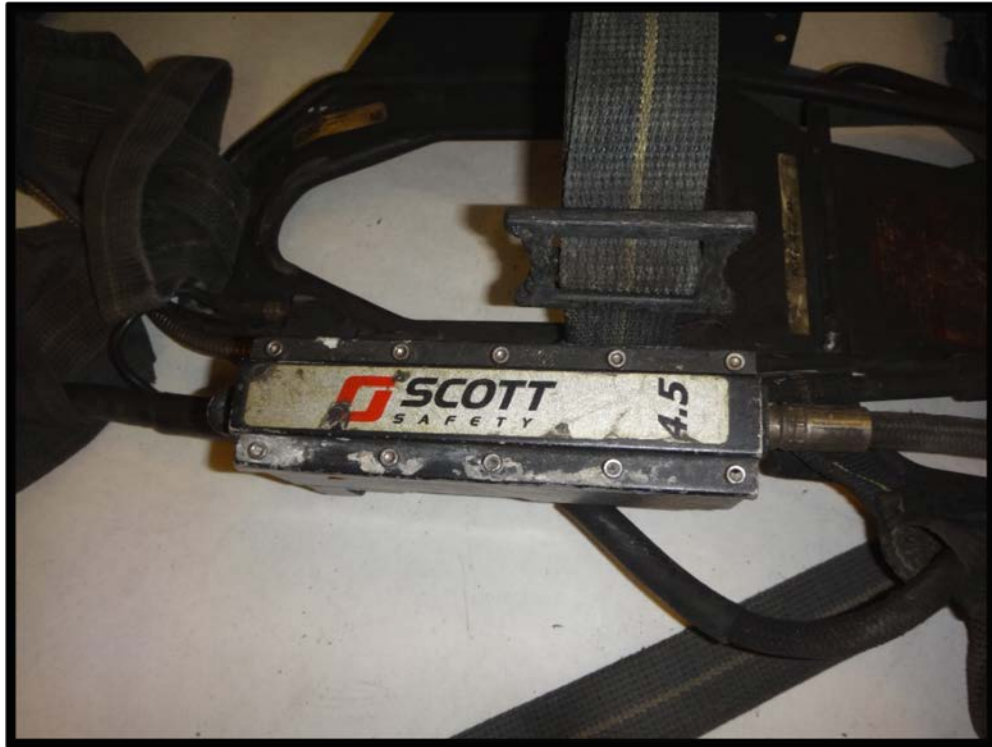
- SCOTT marking is present
- Overall condition is good, some debris on top
- All airline connections are secure with no sign of heat damage
- Low pressure line, dual manifold assembly in pouch and in good condition

**Figure 17: Top view of pressure reducer assembly**

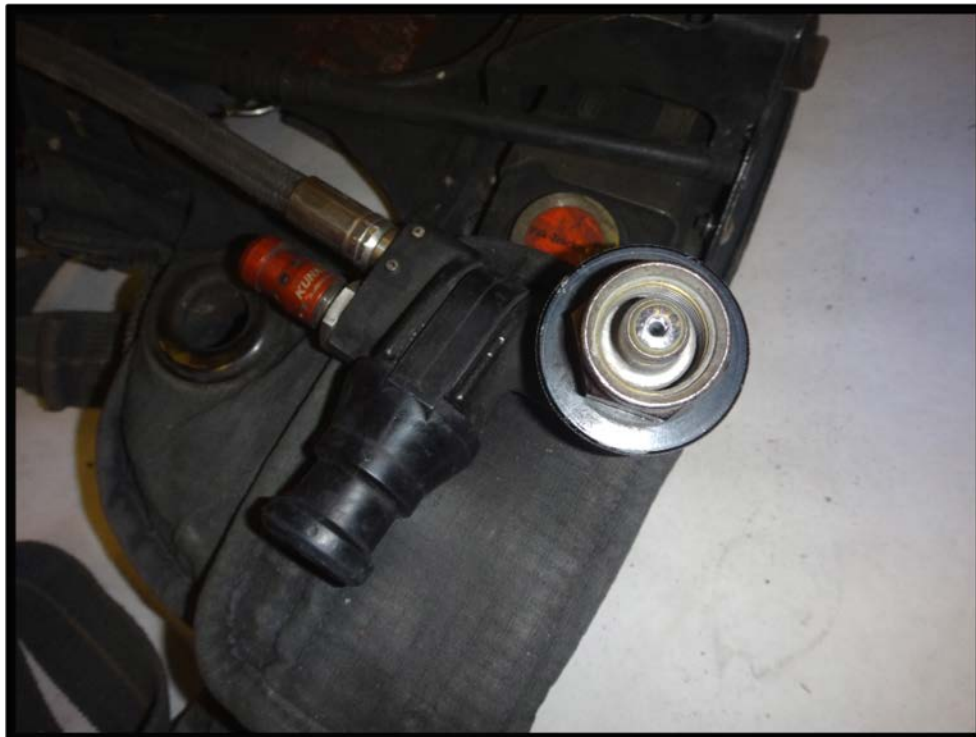
- Overall condition is good
- Cylinder attachments thread clean, threads on and off, O-ring in place
- Quick fill cover in good condition, connection clean

**Figure 20: Cylinder attachment and O-ring clean**

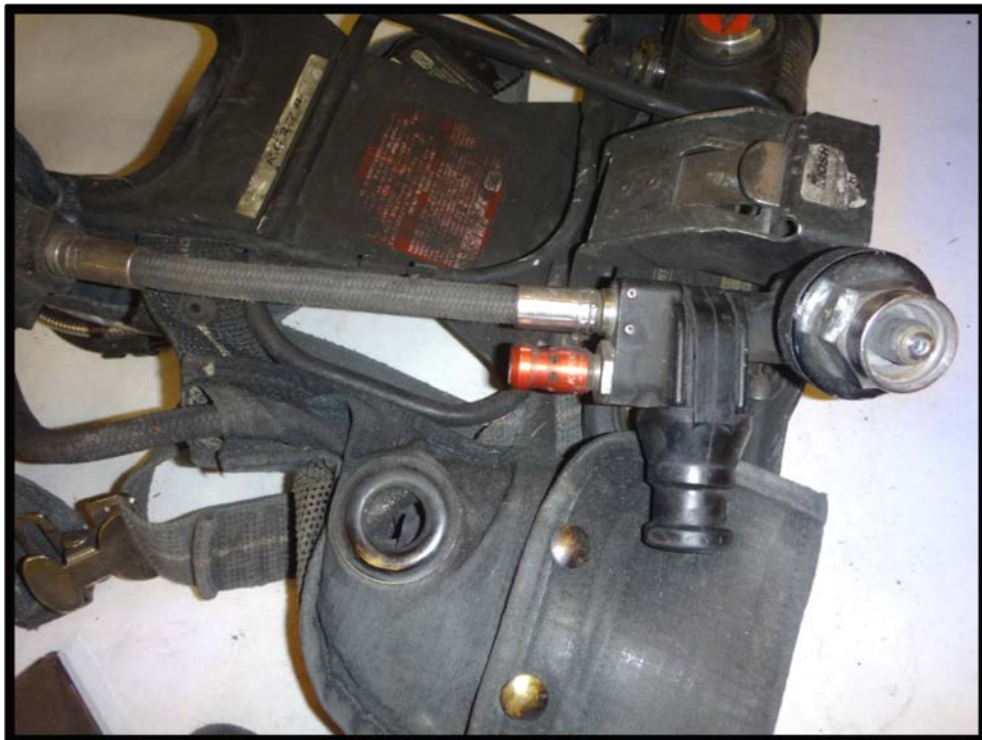
**Figure 21: Quick fill overall condition is good**

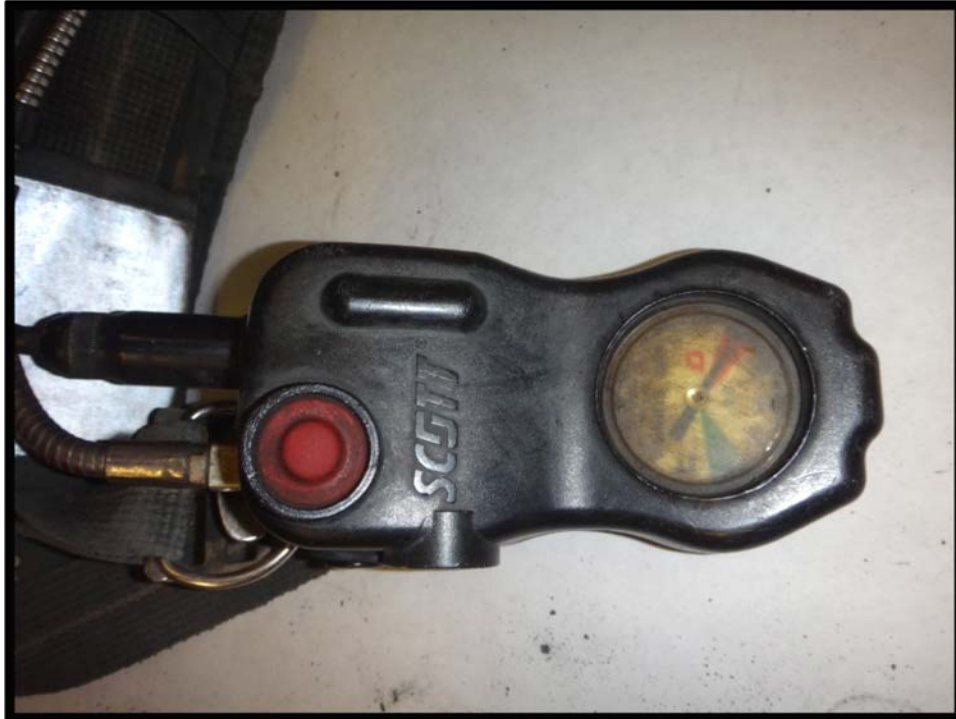
- Overall condition is good
- Lines good shape—pressure/electrical
- Gauge lens is good and readable, but foggy
- Protective casing is good
- Rubber attachment strap present, attached to the PASS console and shoulder strap
- PASS did function
- SEI label present

Figure 23: PASS console

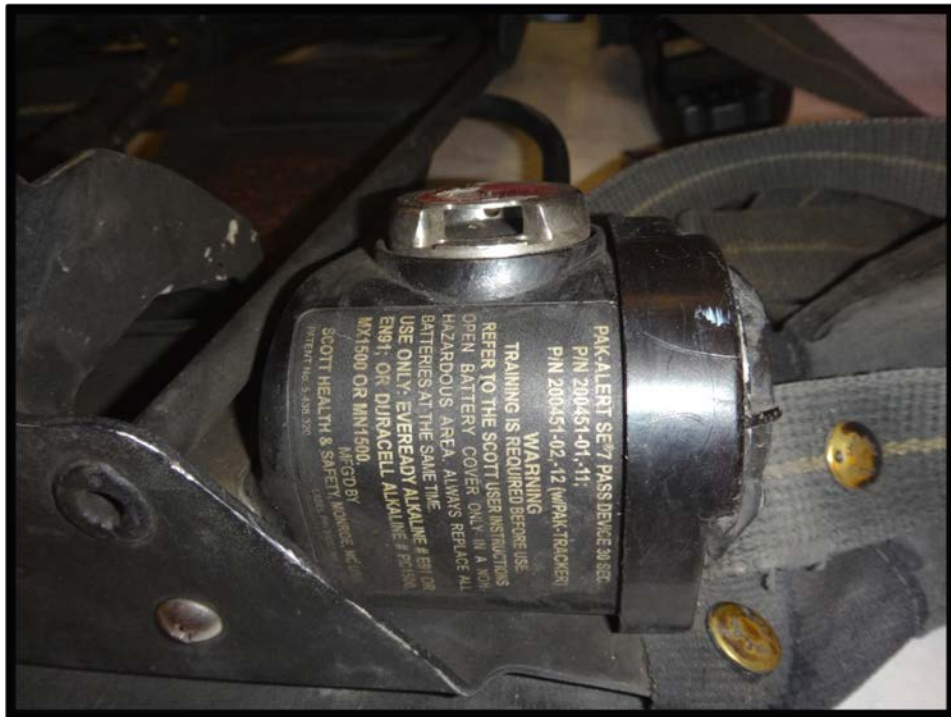
- Overall condition is good shape
- Held securely to backframe
- Wire connection connected to PASS device
- Wire held secure to backframe and runs to console assembly

Figure 26: PASS control module

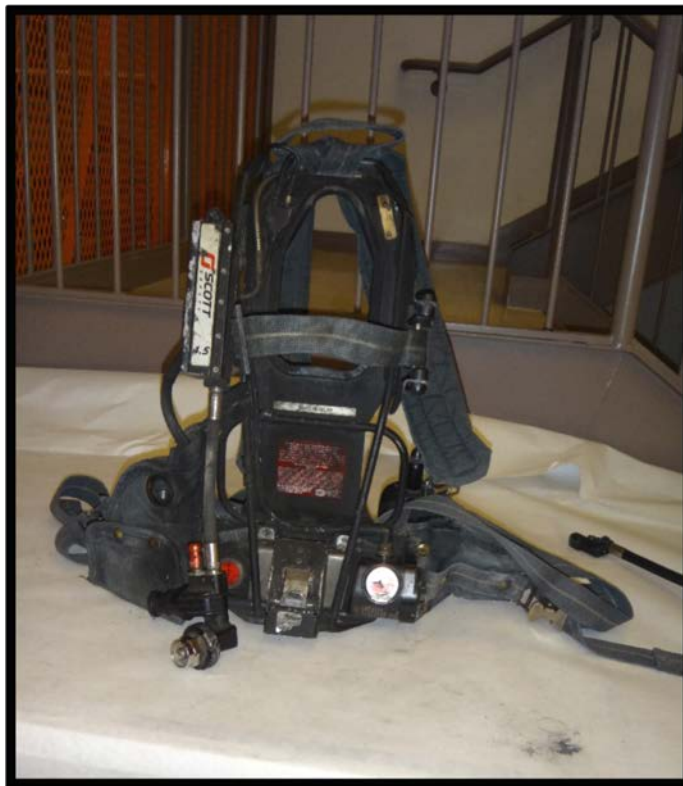
- Overall good condition, no bends/cracks in wire frame, or plate
- Shoulder straps were attached to the frame
- Cylinder strap latch is in fair condition and functional
- NIOSH label present, and readable TC-13F-76CBRN for the unit

**Figure 28: Overview of backframe**

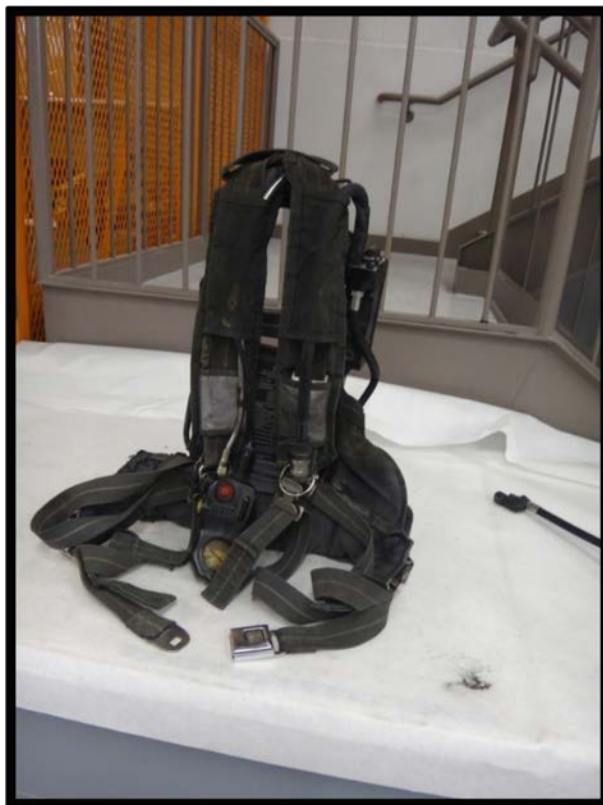
**Figure 33: Overview of straps and buckles**

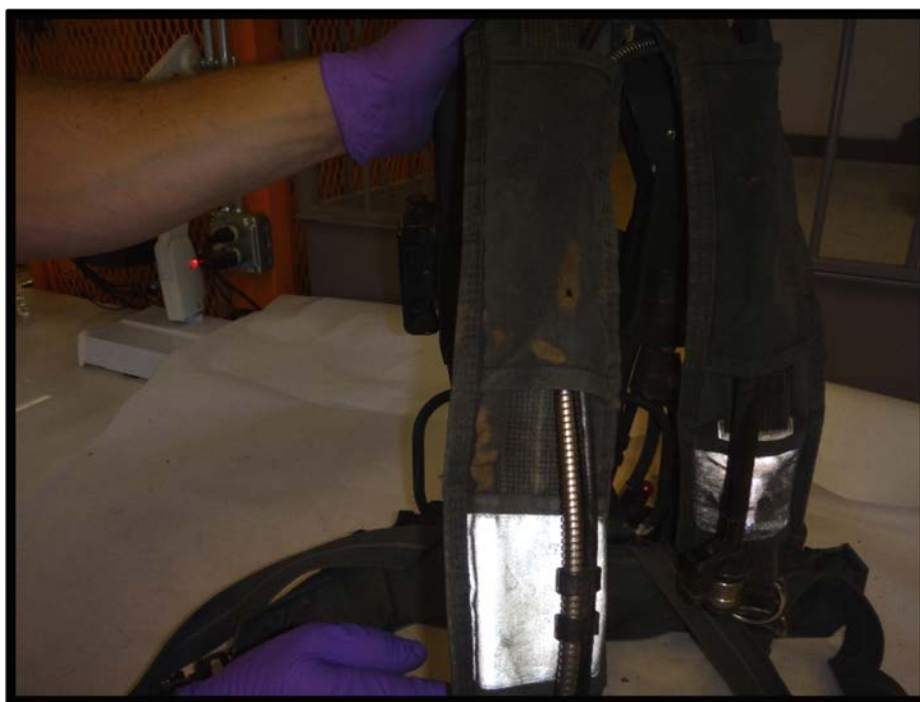
- Overall strap condition is good but dirty with some signs of heat damage, dye sublimation
- Both shoulder straps attached at the top of the backframe
- Hose lines and wires pass through shoulder straps
- All adjustable buckles move and hold in place
- Waist area buckle latches and release
- Lumbar strap in good condition

**Figure 34: Shoulder straps have signs of heat damage**

Before this unit is to be placed back into service, the SCBA must be repaired, tested, cleaned, and any damaged components replaced and inspected by a qualified service technician, including such testing and other maintenance activities, as prescribed by the schedule from the SCBA manufacturer. Typically a flow test should be conducted in accordance with the manufacturer instructions and is required at least annually.

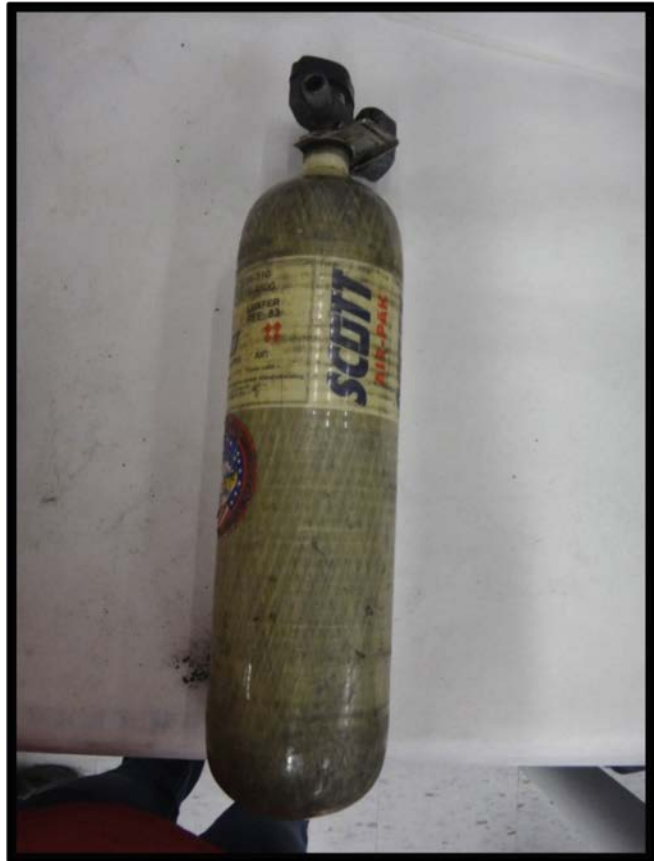
- Overall condition is good as there are some surface scratches and dirt present (minimal)
- Gauge is readable
- Threads clean but some are damaged
- As received cylinder valve fully closed with no air remaining
- Rubber bumper at base on cylinder valve is in fair condition
- Rehydro label present: (Partial) ??/13
- P/N for assembly/cylinder not readable
- On Stem: (Partial#) 804721-01

**Figure 35: Overview of cylinder**

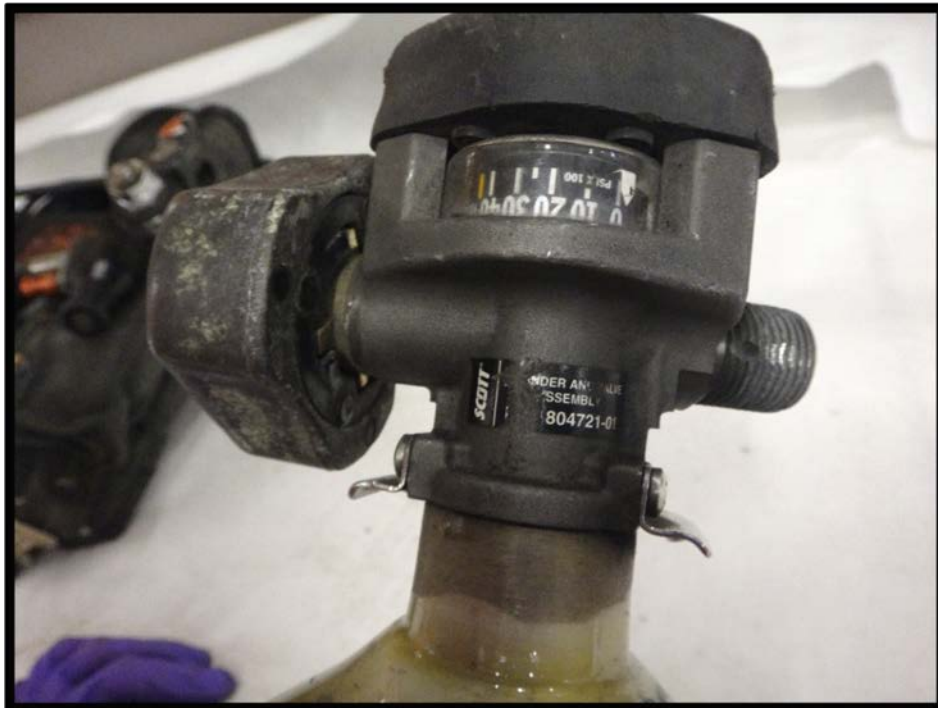
**Figure 36: Cylinder gauge is readable**

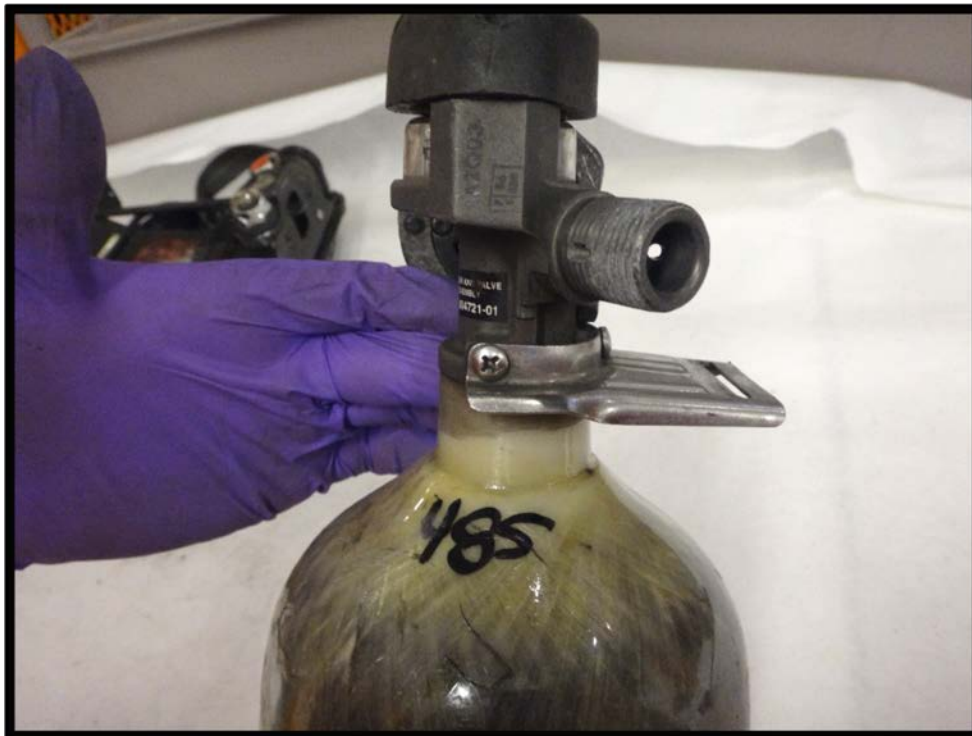
Figure 38: Cylinder valve threads are clean with some damage to threads

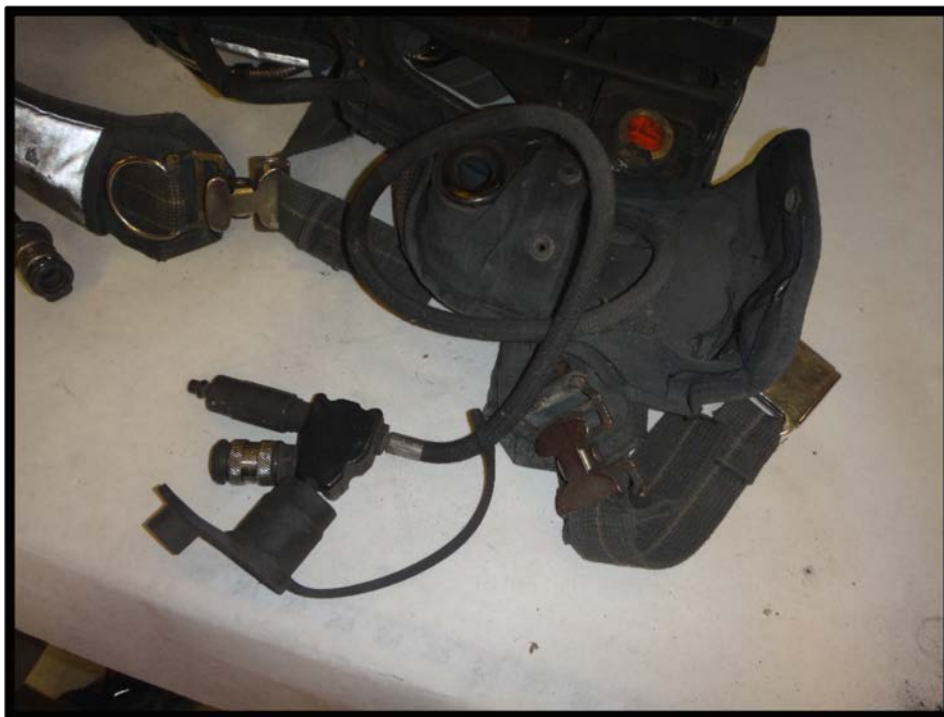
- Overall condition is good and rubber protective boots are in good shape
- Straps attached to covers and cylinder attachment assembly
- Fittings are clean

**Figure 39: Auxiliary hose assembly in good condition**
